INTRODUCTION

Larson Engineering inspected the exterior masonry cladding on the XYZ Plaza buildings during June and July, 2002. The inspections showed that deterioration of the exterior cladding continues, and with it, the need for repair and maintenance. The majority of the brick and limestone cladding is currently in fair to poor condition.

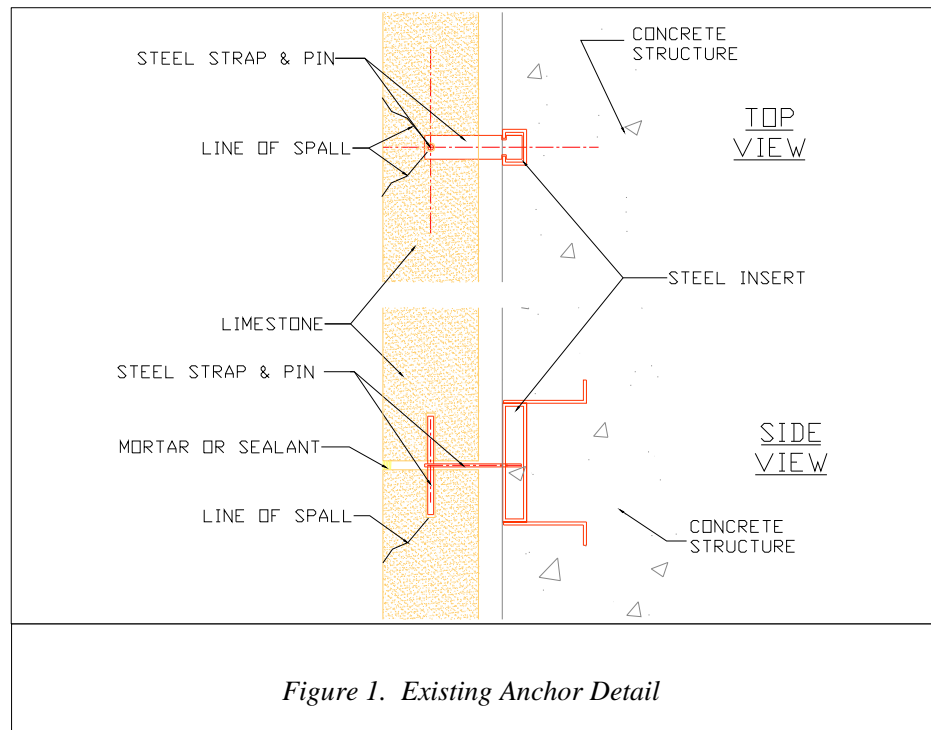
The most common type of failure of the limestone is spalling or cracking of the stone along the top and bottom edges of the stone where the anchors are located. The anchors that tie the stones back to the building consist of a steel pin inserted into the stone and through a steel "dove-tail" strap that slips into slotted inserts in the structure behind the stone. See Figure 1.

Water that gets behind the stone causes the pin to rust, and with the rusting comes an increase in the volume of the pin that exerts pressure on the stone, eventually causing the stone to crack and spall. In addition to the swelling of the anchor, the water that causes the rusting may itself be freezing and expanding, placing additional stress on the stones.

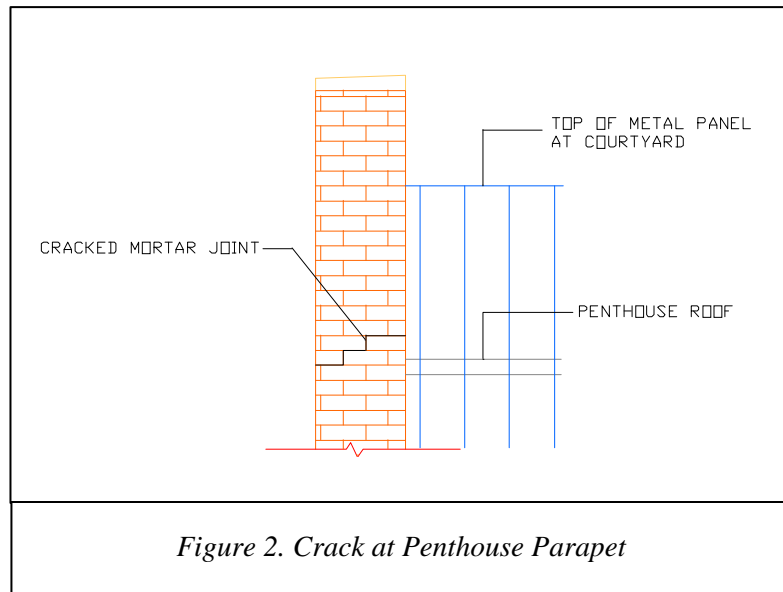
At the elevator penthouse on the hotel building, a cracked mortar joint “steps” through the thickness of the parapet wall to the left when viewed from the courtyard. Please refer to Figure 2. The location of the crack is at approximately the level of the penthouse roof, and is indicative of a failure due to water from the roof entering the brick wall and freezing. It should be verified that the roof of the penthouse is properly flashed and drained to prevent water entering through the back of the penthouse wall.
